INDOOR AIR QUALITY ASSESSMENT

**Amvets Boulevard Elementary School
70 Amvets Boulevard
North Attleborough, Massachusetts**

Prepared by:
Massachusetts Department of Public Health
Center for Environmental Health
Bureau of Environmental Health Assessment
Emergency Response/Indoor Air Quality Program
September 2004

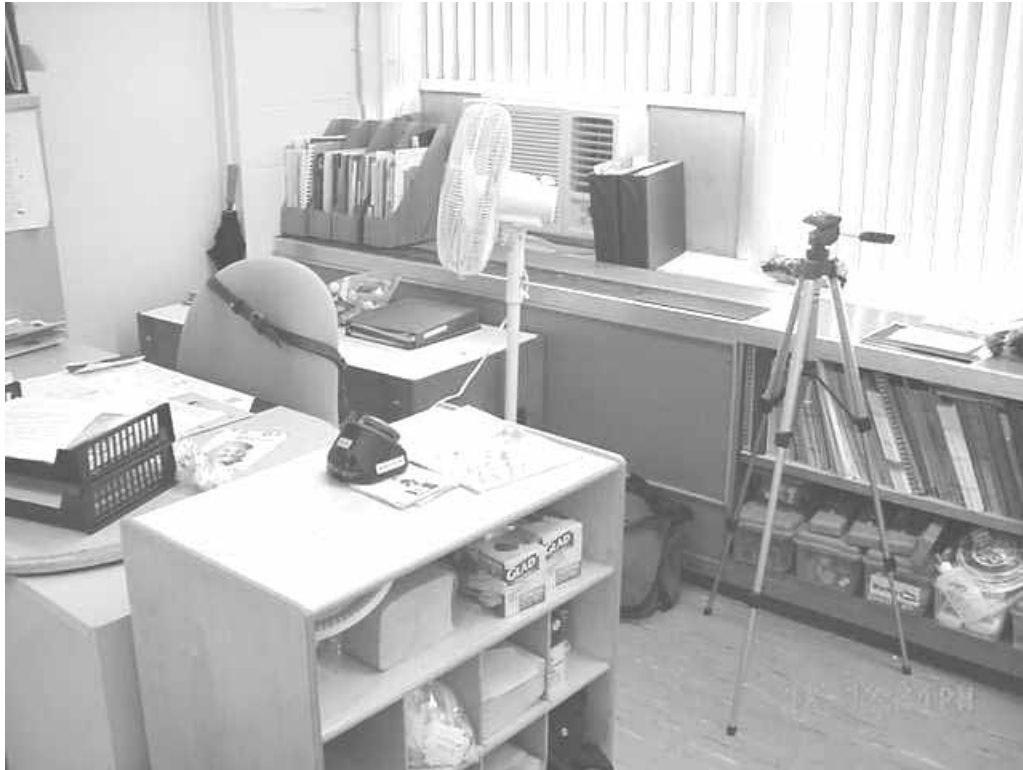
Picture 3

mechanical means to introduce air into the building (Table 1). Obstructions to airflow, such as items on and/or in front of univents were seen in a number of classrooms (Picture 3). The air intake on the exterior of classroom 15 was completely obstructed with plywood (Picture 4). In order for univents to provide fresh air as designed, these units must remain “on” and allowed to operate while these rooms are occupied. Importantly, intakes, diffusers and returns must remain free of obstructions.

Univent Obstructed by Items on Top and in Front of Return Vent

6. Remove all blockages from univents and exhaust vents to ensure adequate airflow.
7. Consult a ventilation engineer concerning re-balancing of the ventilation systems.
Ventilation industrial standards recommend that mechanical ventilation systems be balanced every five years (SMACNA, 1994).

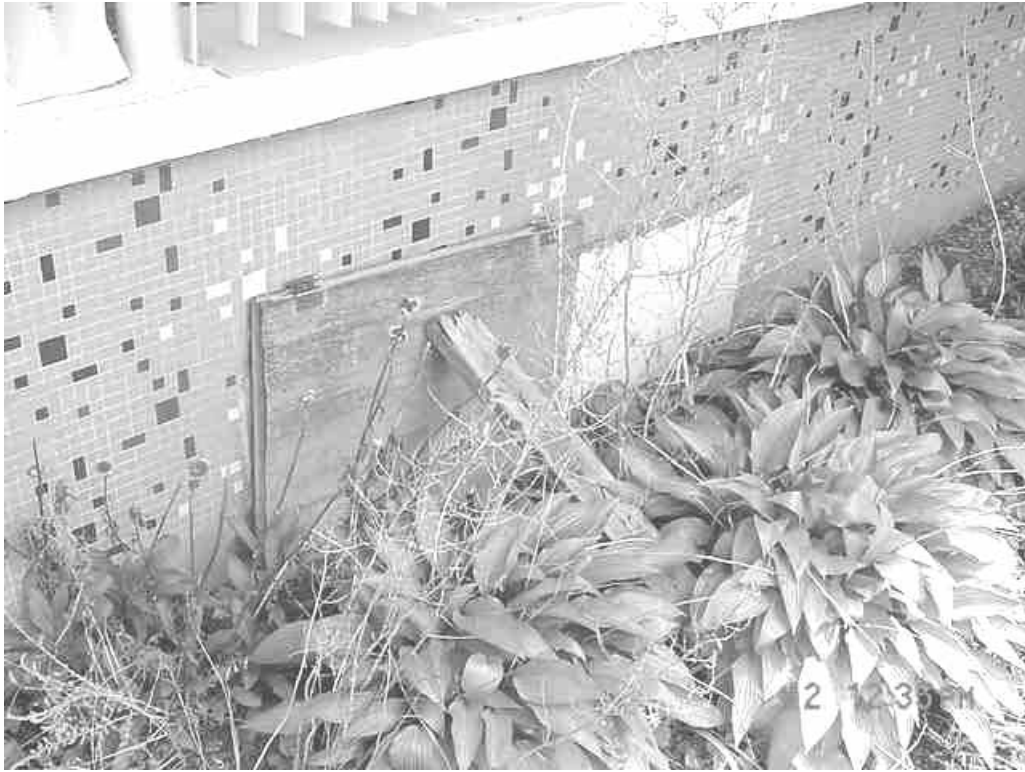
Picture 4

Univent Fresh Air Intake Blocked by Plywood

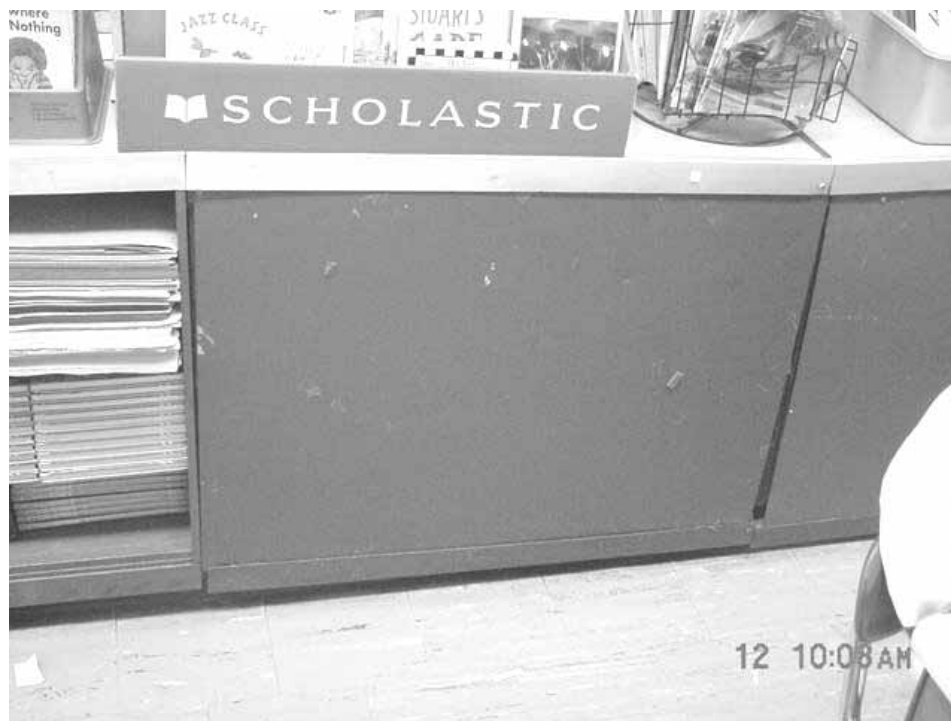
Picture 5

Mechanical exhaust ventilation in classrooms is provided by unit exhaust ventilators (Picture 5). A unit exhaust ventilator appears similar to a univent, but removes air from the classroom and pushes it out of the building (Picture 1). Unit exhaust ventilators were not operating at the time of the assessment and appeared not to have been operating for some time. BEHA staff examined the interior of several of these units and found units were deactivated or motors were unplugged (Picture 6). Mr. Haggerty plugged in the unit exhaust ventilator in classroom 13 and the unit reactivated. Without proper supply and exhaust ventilation, normally occurring environmental pollutants can build-up and lead to indoor air quality/comfort complaints.

Unit Exhaust Ventilator in Classroom

4. Continue to operate modular classroom thermostat in the fan “on” setting during occupancy to provide continuous air circulation.
5. Inspect exhaust motors and belts for proper function. Repair and replace as necessary.

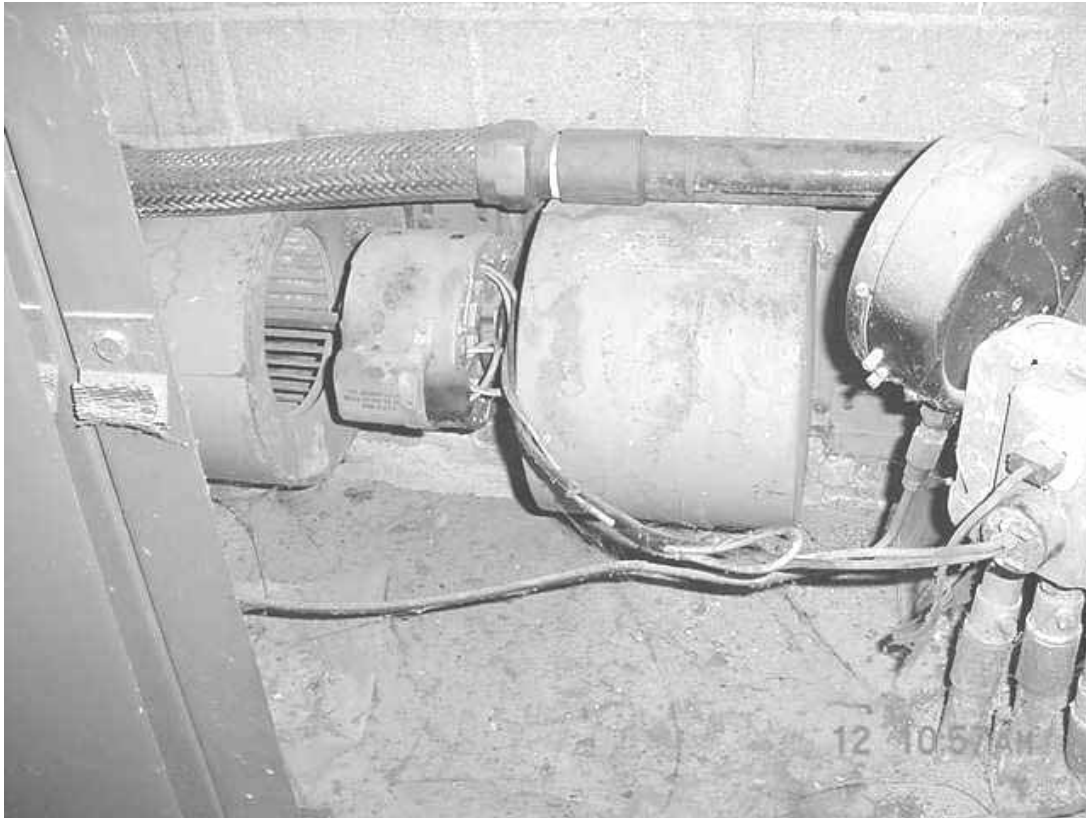
Picture 6

Mechanical Components (fans, motor, etc.) of Unit Exhaust Ventilator

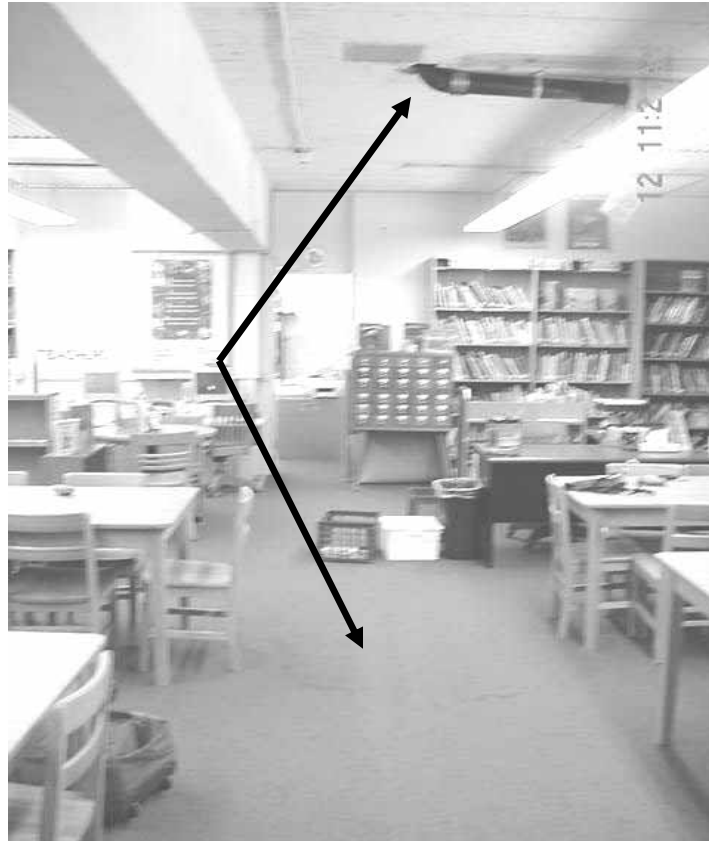
Picture 7

BEHA staff were asked to examine carpeting in the library. The carpet is reportedly moistened periodically. In order for building materials to support mold growth, a source of moisture is necessary. Identification and elimination of water moistening building materials is necessary to control mold growth. Building materials with increased moisture content over normal concentrations may indicate the possible presence of mold growth. Identification of the location of materials with increased moisture levels can also provide clues concerning the source of water supporting mold growth. In this case the most obvious source of moisture was a roof drain, as evidenced by a water stain located directly below it (Picture 7).

Roof Drain and Water Damaged Carpet in Library

9. Ensure all roof leaks are repaired. Continue with plans to replace the section of water-damaged carpet in library and any remaining water-stained ceiling tiles. Examine the areas above and around these areas for mold growth. Disinfect areas of water leaks with an appropriate antimicrobial.

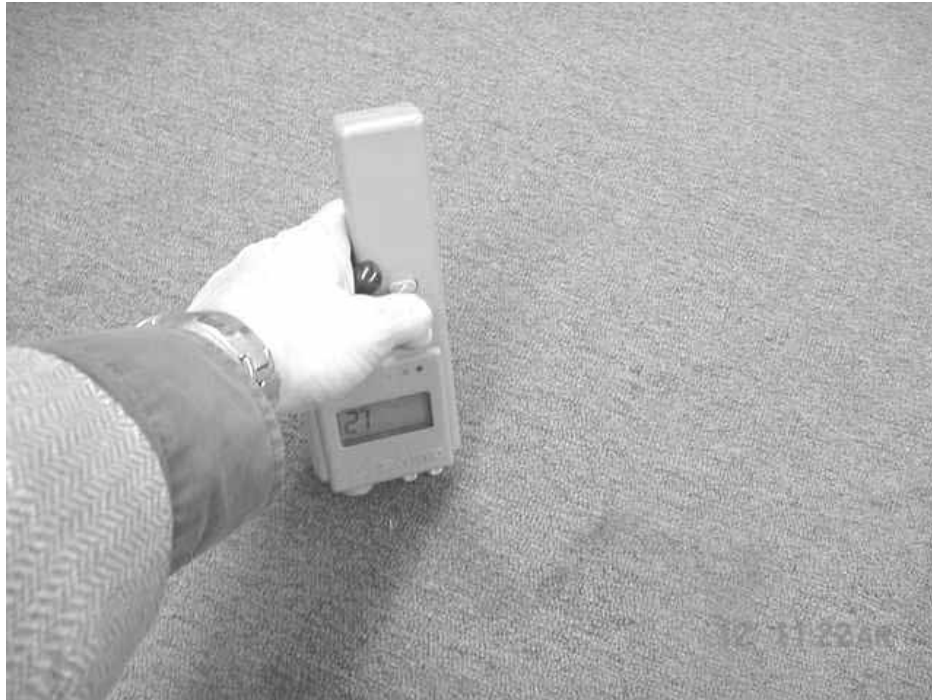
Picture 8

In an effort to ascertain moisture content of carpeting in the library, measurements were taken directly below the roof drain. A number of non-affected areas of the library carpet were measured for comparison. A Delmhorst, BD-2000 Model, Moisture Detector with a Delmhorst Standard Probe was used to ascertain moisture content. The probe was inserted into the surface of carpeting. The Delmhorst probe is equipped with three lights that are visual aids for determining moisture level. Readings that activate the green light indicate a sufficiently dry level (0 - 0.5%); those that activate the yellow light indicate borderline conditions (0.5 – 1.0%) and those that activate the red light indicate elevated moisture content (> 1%).

Elevated moisture content was measured in carpeting directly beneath the drain (Picture 8/Table 1). At the time of the assessment, BEHA staff recommended removing/replacing this section of carpeting and inspecting the roof drain for proper drainage. In a subsequent conversation with Mr. Denault, it was reported that the section of water-damaged carpet would be removed and replaced with tile prior to the beginning of the 2004-2005 school year. The US

Water Damaged Carpet with Elevated Moisture Content in Library

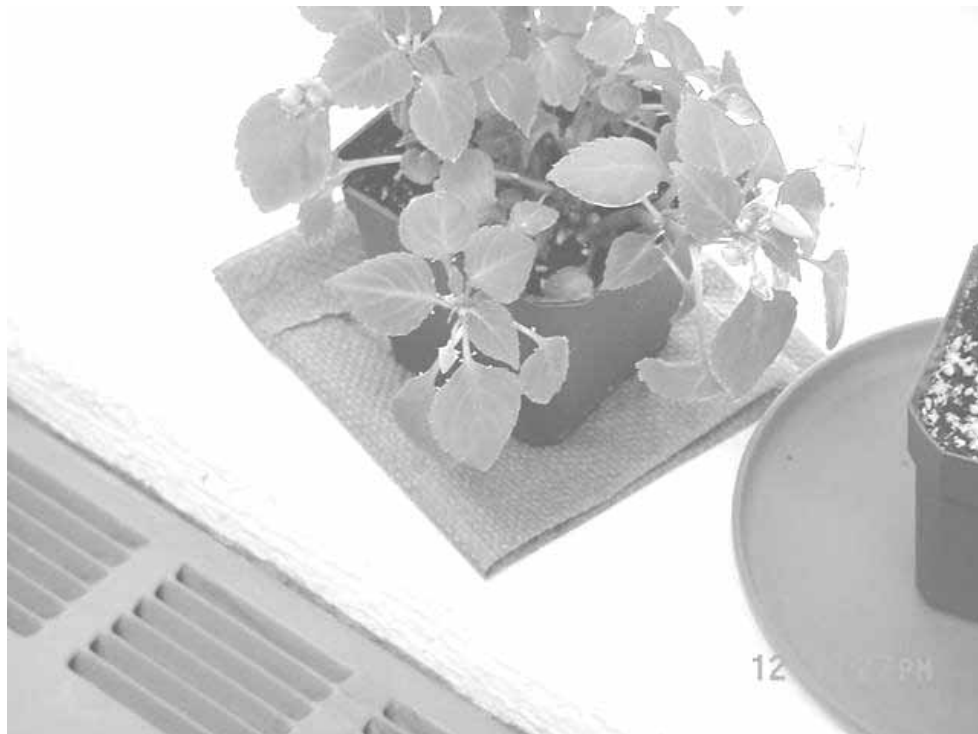
Picture 9

Plants were observed in several classrooms. Plants, soil and drip pans can serve as sources of mold growth. Plants should be properly maintained, over-watering of plants should be avoided and drip pans should be inspected periodically for mold growth. Plants in one classroom were located on top of paper towels (Picture 9). Paper towels are a porous material that can provide a medium for mold growth, especially if wetted repeatedly.

Plant on Saturated Paper Towel in Classroom

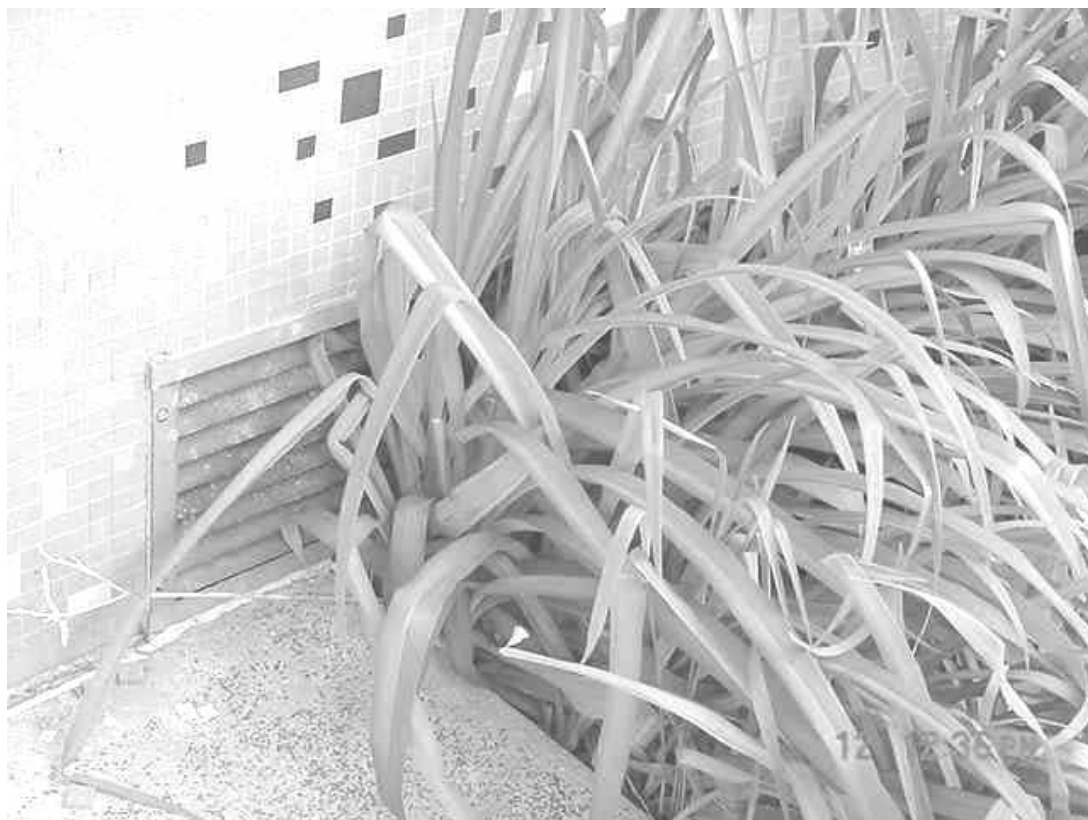
Picture 10

Plants and shrubbery were also observed in close proximity to univent air intakes on the exterior of the building (Picture 10). Plants should be located away from ventilation sources to prevent aerosolization/entrainment of dirt, pollen or mold.

Plants in Close Proximity to Univent Air Intake

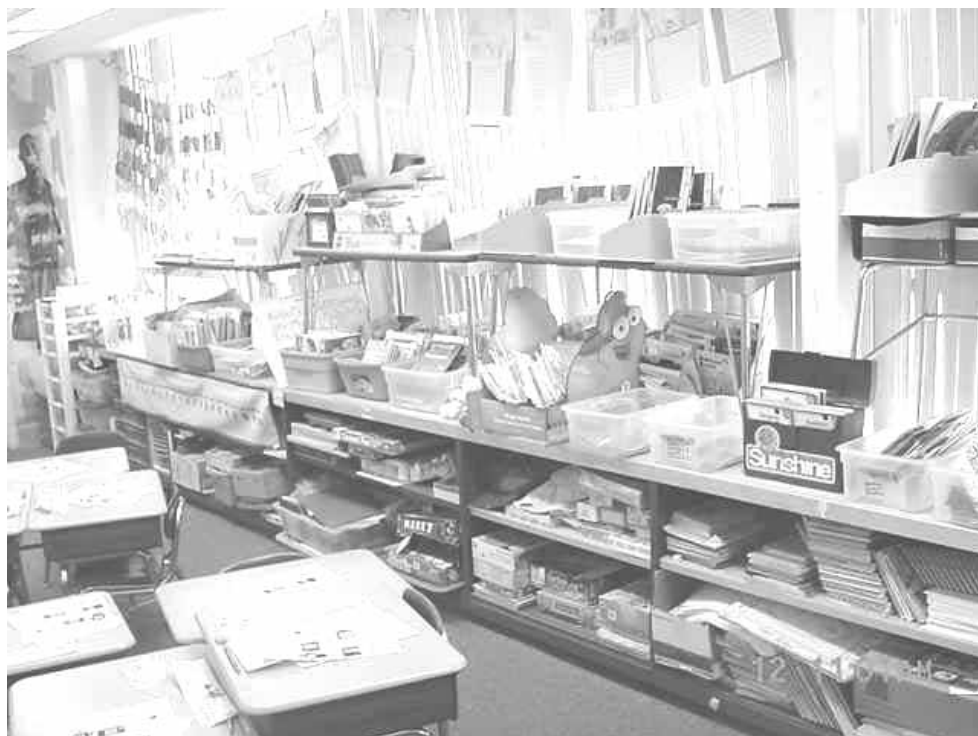
Picture 11

Several other conditions that can affect indoor air quality were observed during the assessment. Of note was the amount of materials stored inside classrooms. In classrooms throughout the school, items were observed on windowsills, tabletops, counters, bookcases and desks. The large number of items stored in classrooms provides a source for dusts to accumulate (Picture 11). These items, (e.g., papers, folders, boxes) make it difficult for custodial staff to clean. Dust can be irritating to the eyes, nose and respiratory tract. Items should be relocated and/or be cleaned periodically to avoid excessive dust build up.

Accumulated Items in Classroom

12. Clean personal fans periodically of accumulated dust.
13. Relocate or consider reducing the amount of materials stored in classrooms to allow for more thorough cleaning. Clean items regularly with a wet cloth or sponge to prevent excessive dust build-up.
14. Clean filters for air purifiers as per the manufacturer's instructions or more frequently if needed. To enhance airflow relocate air purifiers from off of the floor.
15. Consider discontinuing the use of tennis balls on chair legs.
16. Use the principles of integrated pest management (IPM) to prevent pest infestation and rid the building of current pests. A copy of the IPM recommendations can be obtained from the Massachusetts Department of Food and Agriculture (MDFA) website at the following website: http://www.state.ma.us/dfa/pesticides/publications/IPM_kit_for_bldg_mgrs.pdf.

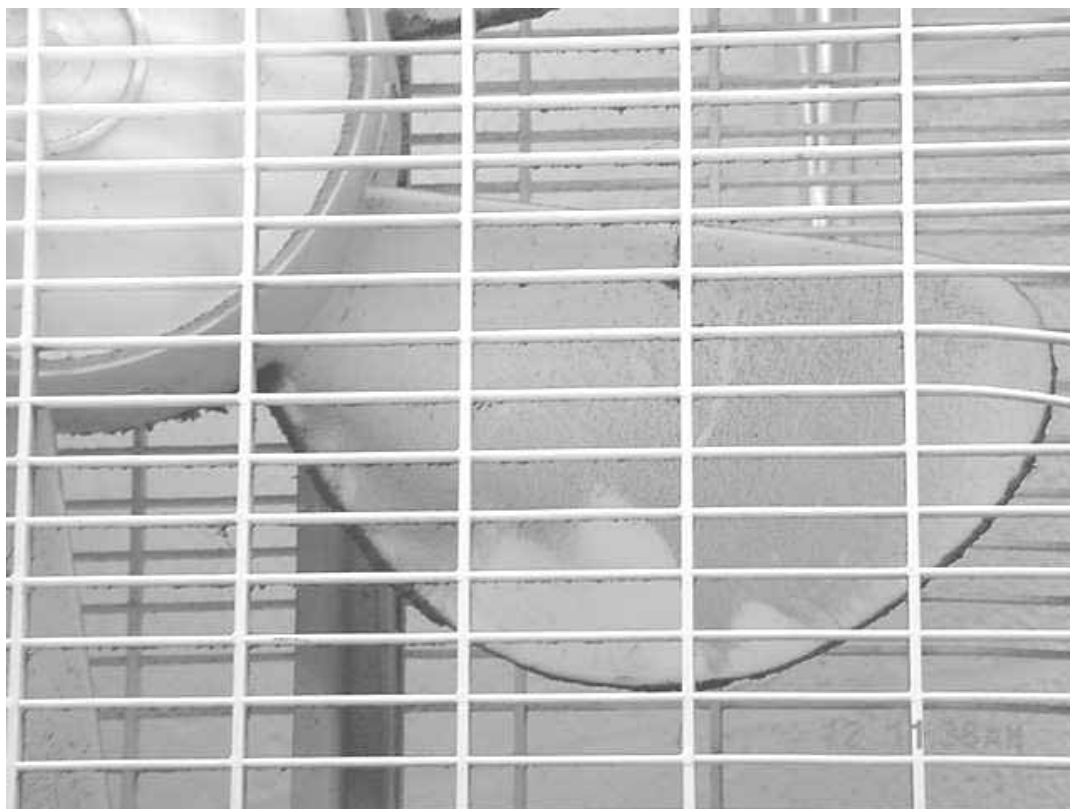
Picture 13

A number of univents had accumulated dust, cobwebs and debris within the air handling chambers (Picture 12). These conditions may be attributed to non-continuous equipment operation, which allows airborne particulates to settle within the units. In order to avoid this equipment serving as a source of aerosolized particulates, these units should remain activated and the air handling sections should be regularly cleaned (e.g., during scheduled filter changes). Several classrooms also contained personal fans. Accumulated dust was seen on the blades of fans (Picture 13), which can be reaerosolized during operation.

Accumulated Dust on Fan Blades

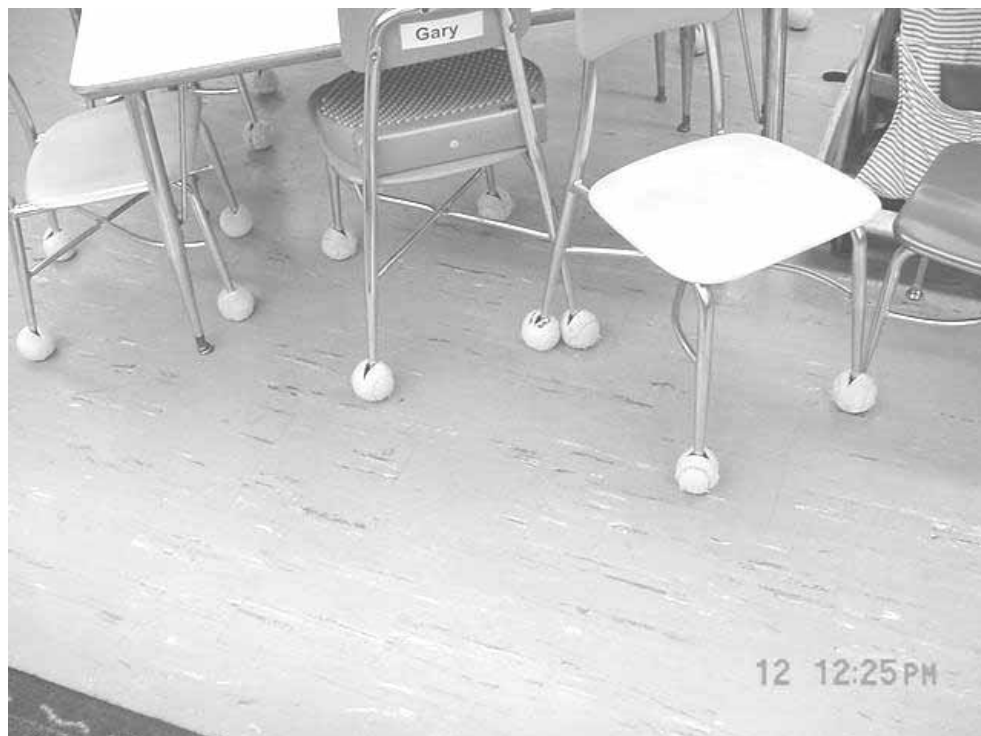
Picture 14

In an effort to reduce noise from sliding chairs, tennis balls had been cut open and placed on chair legs (Picture 14). Tennis balls are made of a number of materials that are a source of respiratory irritants. Constant wearing of tennis balls can produce fibers and off-gas VOCs. Tennis balls are made with a natural rubber latex bladder, which becomes abraded when used as a chair leg pad. Use of tennis balls in this manner may introduce latex dust into the school environment. Some individuals are highly allergic to latex (e.g., spina bifida patients) (SBAA, 2001). It is recommended that the use of materials containing latex be limited in buildings to reduce the likelihood of symptoms in sensitive individuals (NIOSH, 1997). A question and answer sheet concerning latex allergy is attached as [Appendix B](#) (NIOSH, 1998).

Tennis Balls on Chair Legs in Classroom

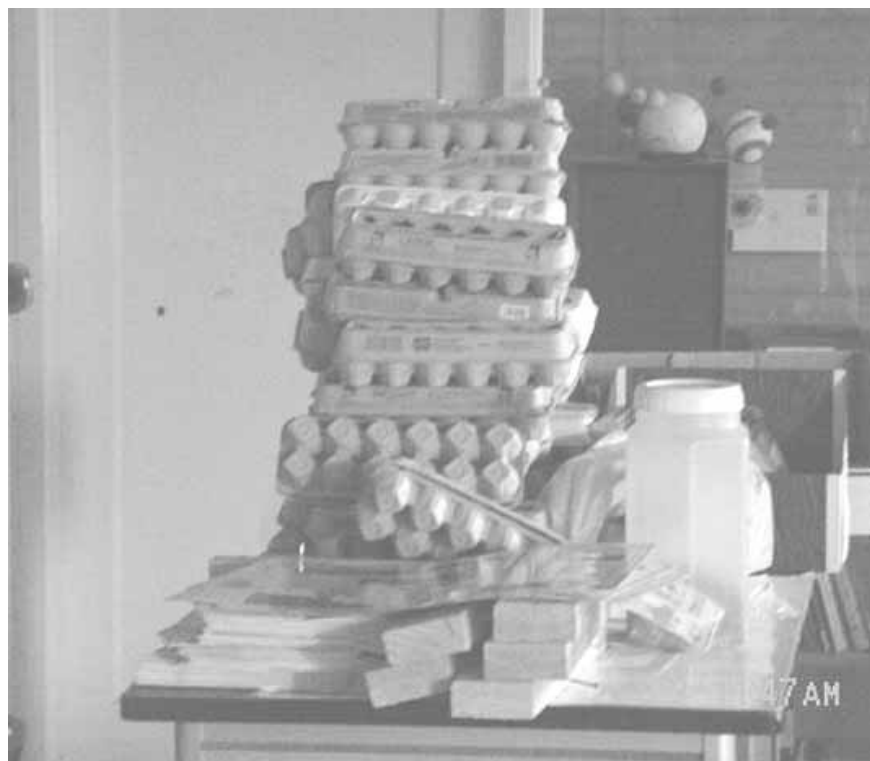
Picture 15

Conditions in classroom 21 may attract rodents. Stored food containers, presumably to be used for art projects were seen (Picture 15). Under current Massachusetts law (effective November 1, 2001) the principles of integrated pest management (IPM) must be used to remove pests in state buildings (Mass Act, 2000). Pesticide use indoors can introduce chemicals into the indoor environment that can be sources of eye, nose and throat irritation. Steps to reduce/eliminate pathways/food sources that can attract pests should be taken.

Empty Egg Containers in Classroom 21

- a) Avoid using food as components in student artwork.
- b) Rinse recycled food containers. Seal recycled containers in a tight fitting lid to prevent rodent access.
- c) Remove non-food items that rodents may consume.
- d) Store foods in tight fitting containers.
- e) Avoid eating at workstations. In areas where food is consumed, vacuum periodically to remove crumbs.
- f) Clean crumbs and other food residues from ovens, toasters, toaster ovens, microwave ovens, coffee pots and other food preparation equipment on a regular basis.

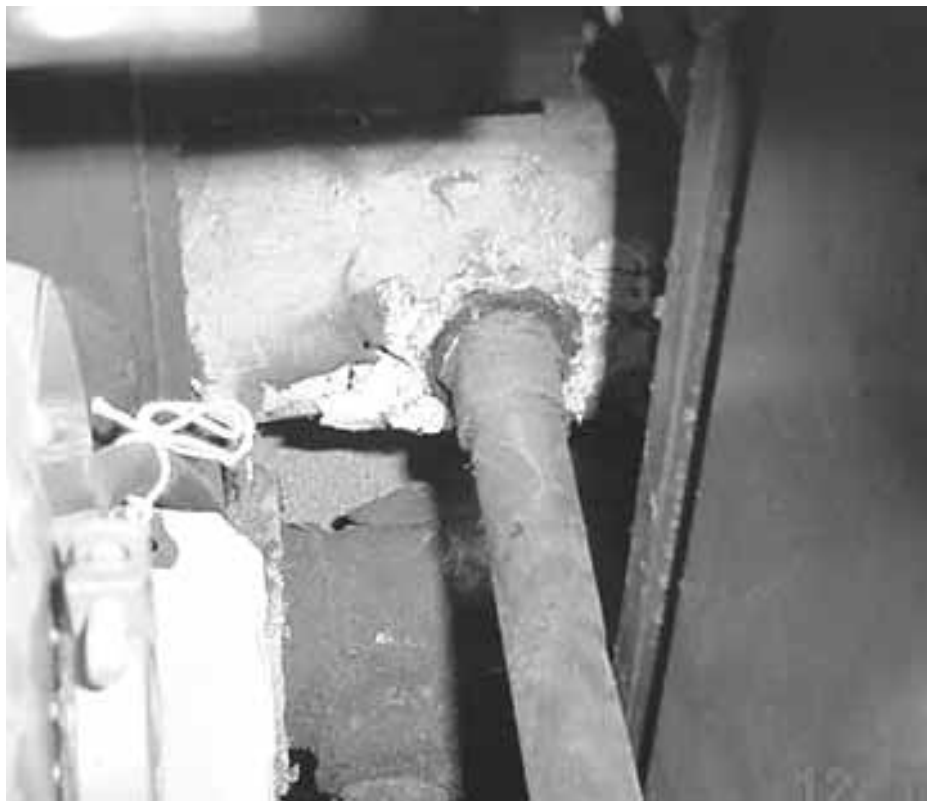
Picture 16

Finally, exposed pipe insulation was observed on pipes in the rear of univent cabinets (Picture 16) that may contain asbestos. Upon discovery, these findings were reported and shown to Mr. Hagerty for more immediate attention. BEHA staff recommended that the material be inspected and encapsulated by a licensed member of the NAPS maintenance staff or other professional contractor as soon as practicable. BEHA staff subsequently contacted Mr. Denault, who reported that the pipe insulation was encapsulated.

Exposed Insulation Material around Univent Pipes in Rear of Cabinet

1. Inspect all univents to ensure exposed/damaged pipe insulation material around univent pipes is encapsulated/remediated in conformance with all applicable Massachusetts' laws.
2. Examine each univent for function. Survey classrooms for univent function to ascertain if an adequate air supply exists for each room. Consider consulting a heating, ventilation and air conditioning (HVAC) engineer concerning the calibration of univent fresh air control dampers throughout the school.
3. Operate all ventilation systems that are operable throughout the building (e.g., gym, auditorium, classrooms) continuously during periods of school occupancy and independent of thermostat control. To increase airflow in classrooms, set univent controls to "high".
